CALIFORNIA DIVISION OF MINES AND GEOLOGY
FAULT EVALUATION REPORT FER-144

Pond Fault, Northern Kern County

Theodore C. Smith
Associate Geologist

April 12, 1983

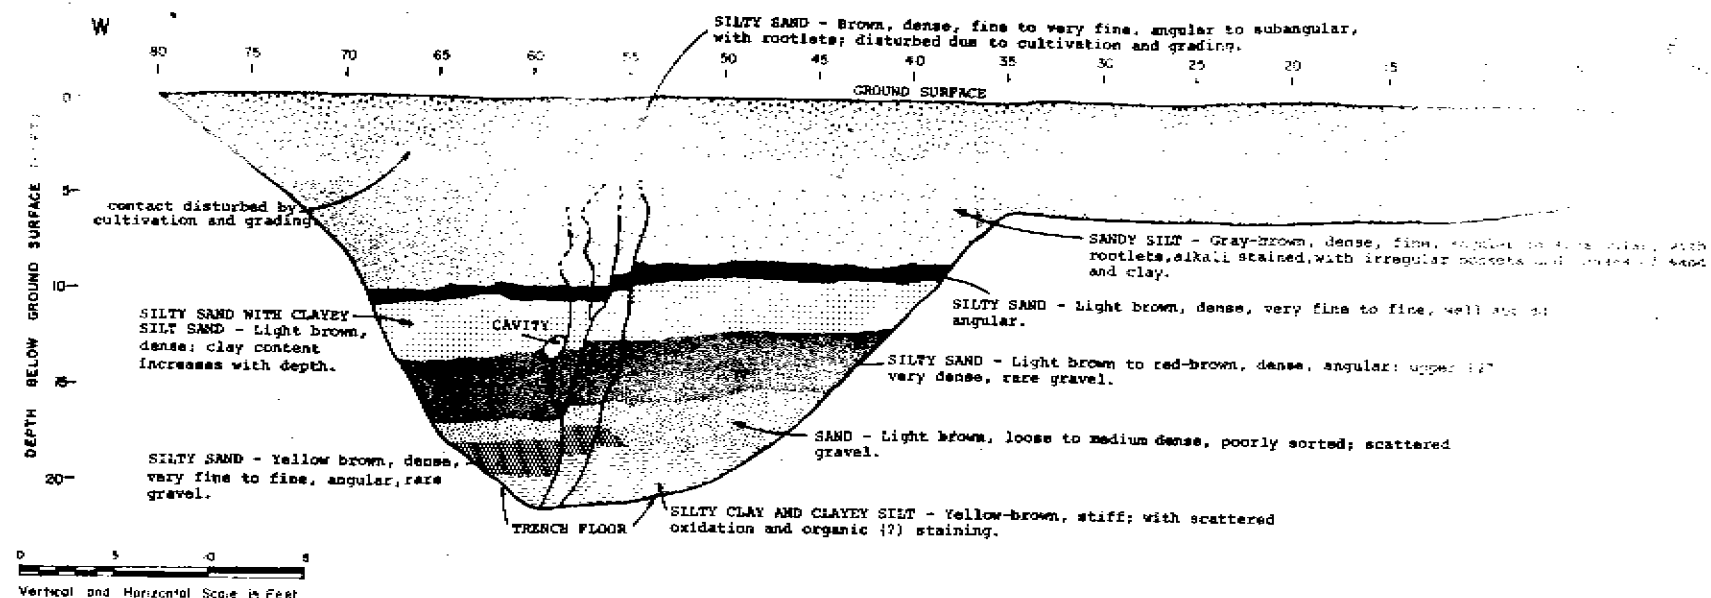
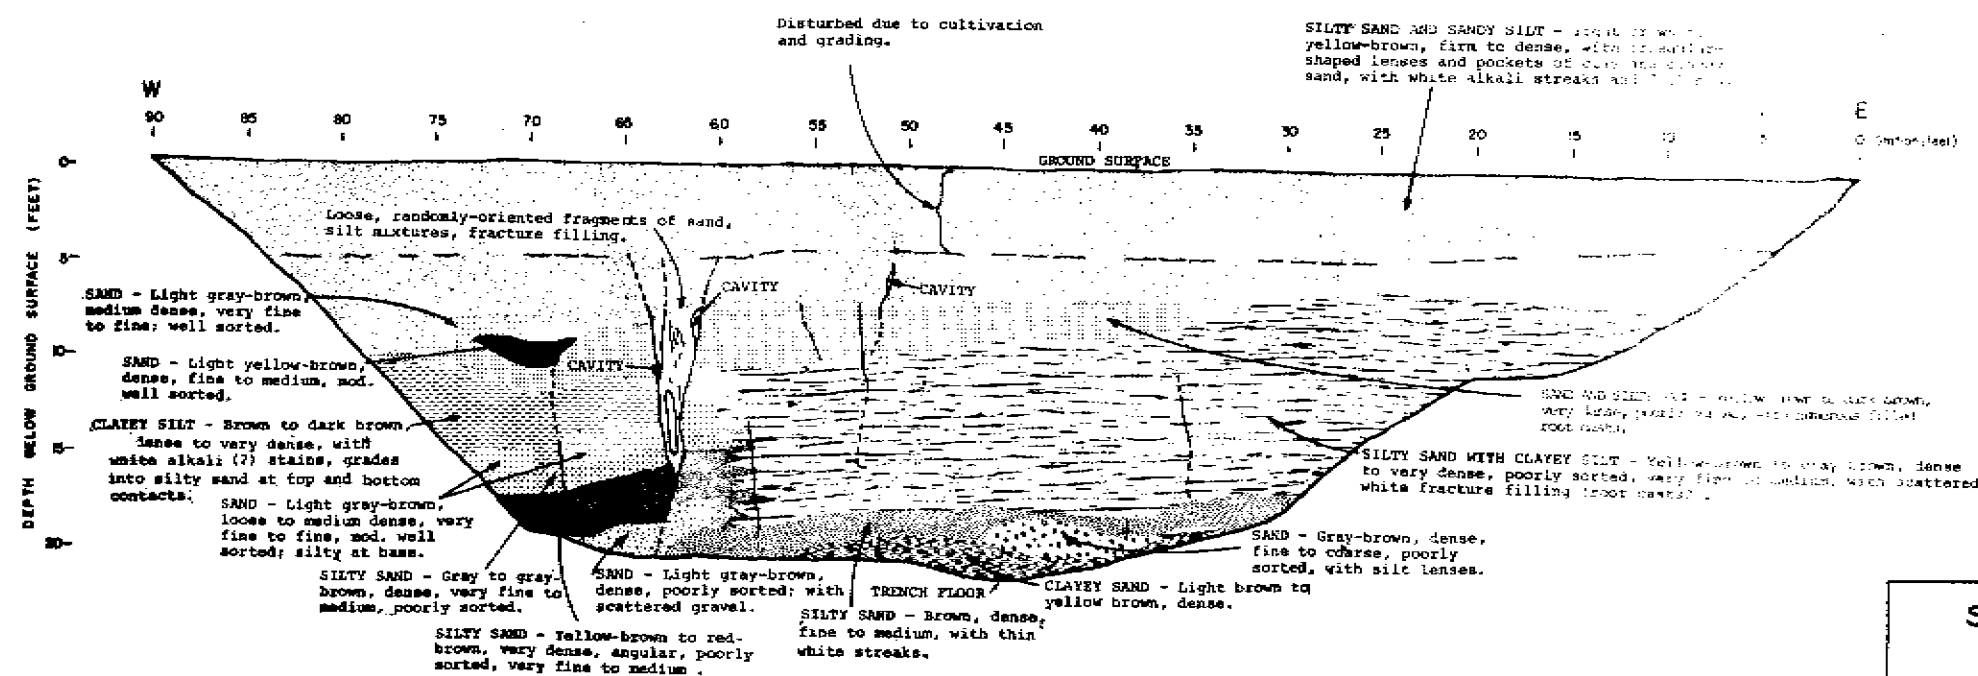
Figure 3. Logs of the trenches across the Pond fault (from LADWP, 1974).

During the investigation of a potential site for a nuclear power plant, evidence of historic fault rupture (creep) was discovered near Pond (Los Angeles Department of Water and Power [LADWP], 1974). The surface evidence consisted of down-dropped roadways, ground cracks and sags, and repeated pipeline ruptures as noted on Figure 2. Subsurface evidence consisted of a groundwater barrier (along Peterson Road the groundwater level in borehole 3 was 50 feet below the surface, and in borehole 8 was 80 to 83 feet below the surface; see Figure 2) and offset stratigraphic horizons (see Figure 3). The latter offset, documented by trenching, amounted to 9" (apparent vertical) at a depth of 10 feet below the surface. LADWP depicts the surficial materials at the trench sites as Modesto Formation (late Pleistocene in age).

TRENCH-1
North Wall

TRENCH-2
North Wall

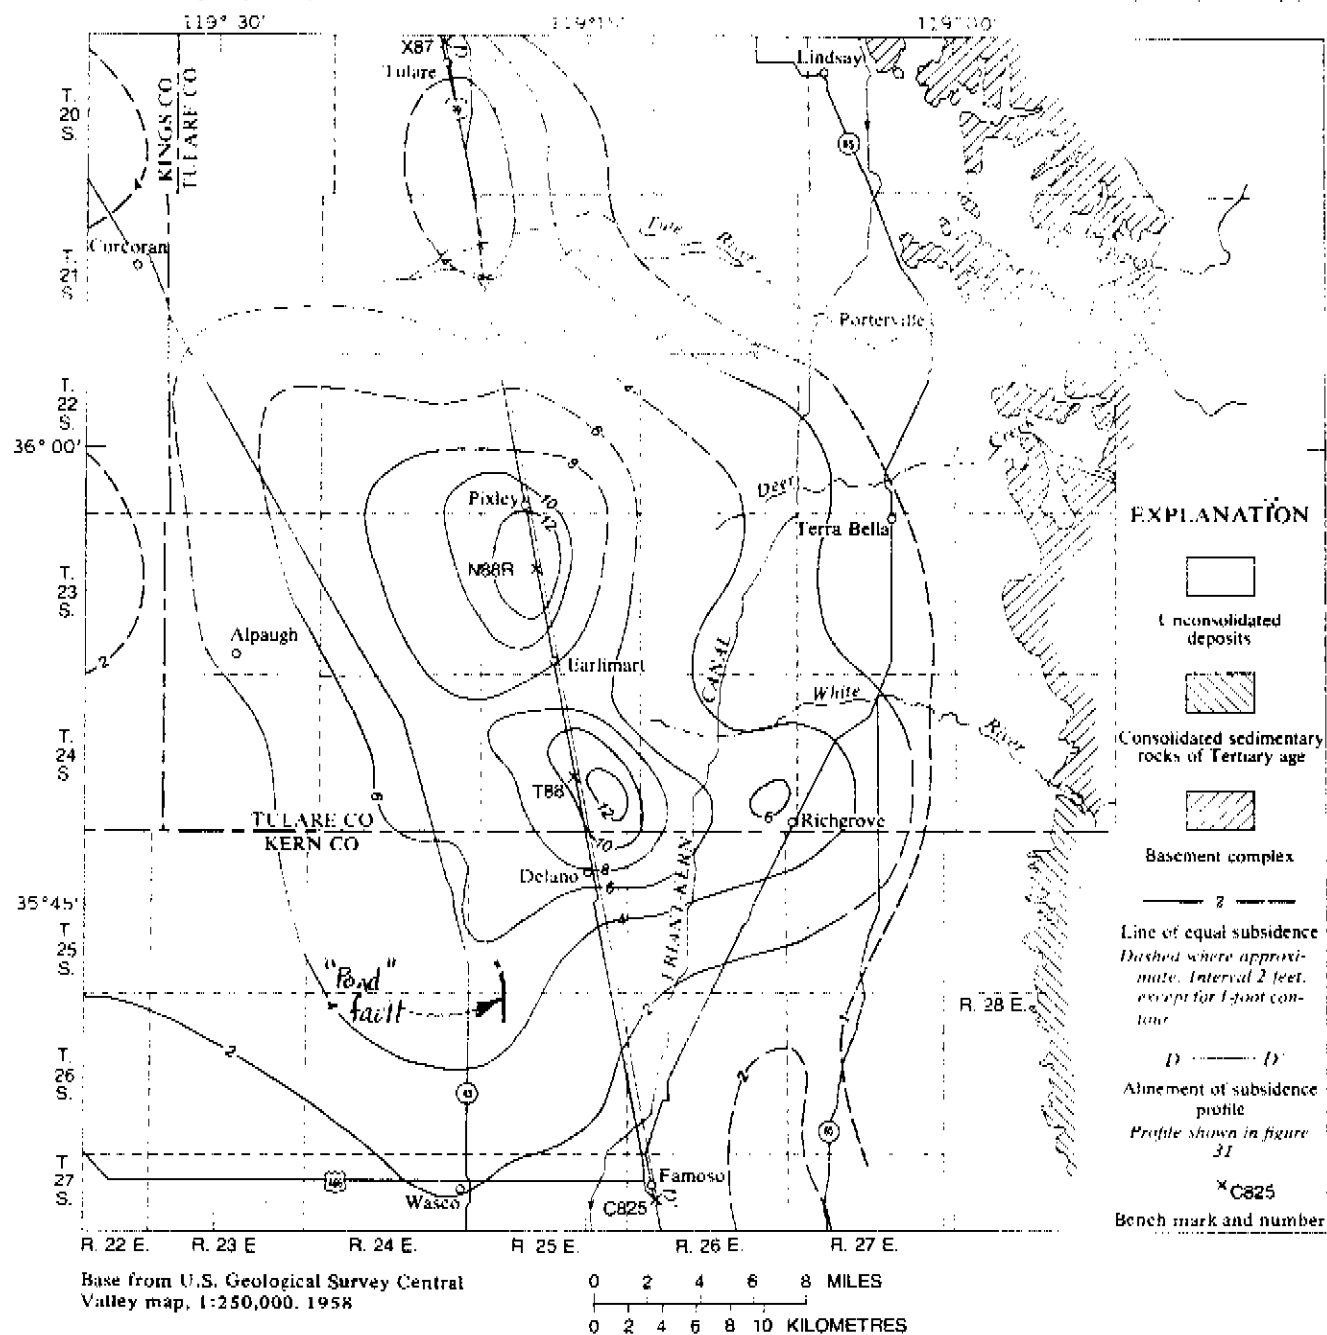
Figure 4. Land subsidence, 1926-1970, Tulare-Wasco area (from Poland and others, 1975). Approximate location of Pond fault indicated in red.

Lofgren and Klausning (1969) and Poland and others (1975) have documented widespread subsidence in the Tulare-Wasco area (Figure 4). The fact that the displacement on the steeply dipping Pond fault appears to be primarily dip-slip (strike-slip evidence has not been reported) and that the groundwater table has been drastically lowered near Pond suggests that subsidence should be considered as a driving mechanism. Ireland and others (1982) indicate that the groundwater aquifer was being compacted at depths equal to those from which water was being produced. They based their conclusions on their observations of numerous wells in the San Joaquin Valley, including one located about 8 miles south of Pond. In the latter, they documented that subsidence was occurring at depths of 2200 feet below the surface.

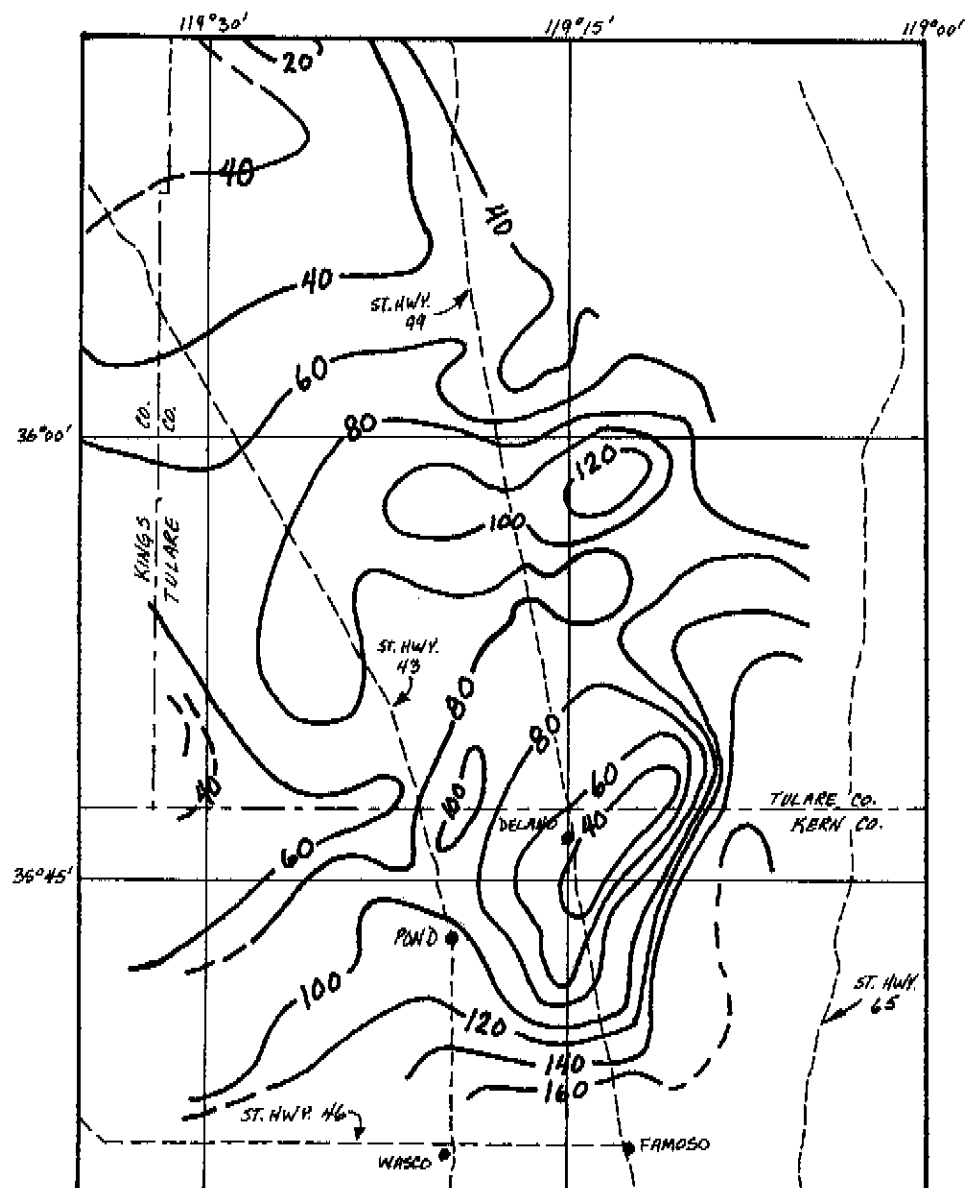
Figure 5. Map showing the decline in the water table, 1920-1959. Contour interval 20 feet. Based on Figures 23 and 28 of Lofgren and Klausing (1969).

Comparison of the elevations of the water table in 1920 with those in 1959 (see Figure 5) reveals that the surface fault near Pond lies on a "water decline gradient". Perhaps this indicates that the subsurface Pond fault acts as a water barrier south of the Kern-Tulare County line where the water table southwest of the fault has declined much more than the water table to the northeast. This relationship appears reversed north of the county line. Therefore, if the continuing withdrawal of groundwater has resulted in surface displacement on the Pond fault (due to differing rates of subsidence on either side), then surface faulting hypothetically should neither continue northward nor southward without radically changing strike. If, however, the fault existed as a surface feature prior to the completion of the Friant-Kern Canal, then it may extend beyond into the adjacent areas.

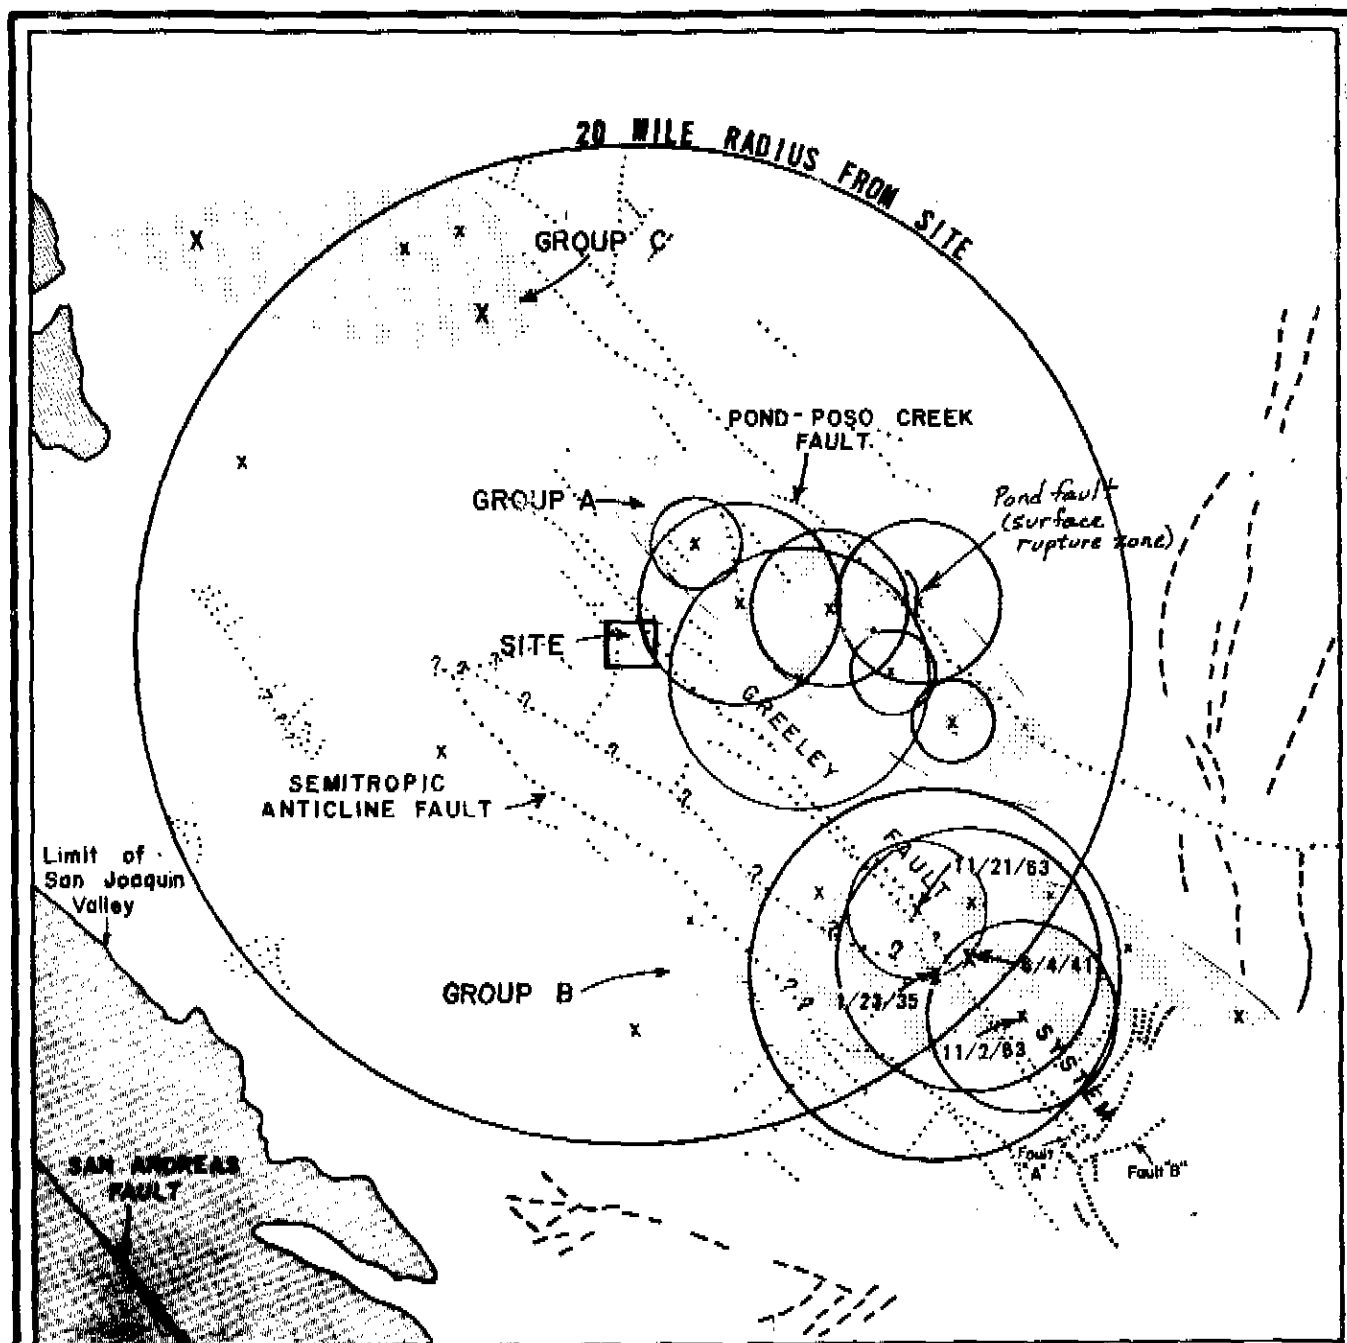
FER-144. Figure 7. Map of earthquake epicenters in the vicinity of the Pond fault (after LADWP, 1974).

Real and others (1978) report no epicenters in the area studied herein (they show only earthquakes larger than magnitude 4.0). LADWP (1974) show six small (M 3.0-3.9) earthquake epicenters located within 6 miles of the Pond fault (Figure 7). This apparent zone of seismicity is centered about 4 miles south of and subparallel to the subsurface fault zone identified as the Pond-Poso Creek fault by LADWP. Although the surface projection of the subsurface fault zone lies in the "circle of horizontal location uncertainty," as calculated by LADWP, of only three of these epicenters, the pattern of epicenters appears consistent with the postulated southwesterly dip of the fault. The zone of surface faulting lies in the "circle of horizontal location uncertainty" of only one of these epicenters. These data suggest that the Pond fault might be seismically active, but are not conclusive.

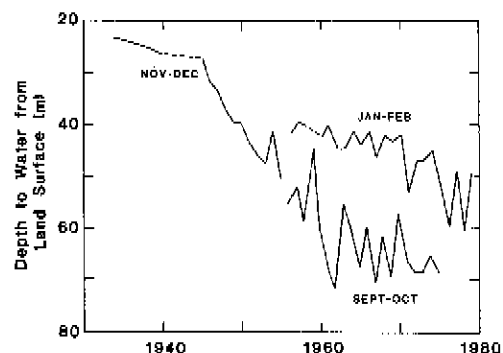
Fig. 3. Graph of water levels for different months in irrigation well 25/25-28R1 (see Figure 2 for location). January-February and September-October measurements are approximately the highest and lowest annual water levels, respectively.

The seasonal variation of water levels was monitored by repeated measurements in an abandoned irrigation well, 26/25-6A1, approximately 1 km west of the fault scarp (Figure 2). Records on file with the California Department of Water Resources report that the well is perforated from 61 to 213 m. In addition to showing a large seasonal fluctuation of water level the hydrograph (Figure 4c) also illustrates the effect on water levels from a drought in the mid-1970's. In 1976 and 1977, imports of surface water via the Friant-Kern Canal were greatly curtailed by the drought (Table 1) and the deficiency was made up by pumping groundwater. In 1978 the return of surface water supplies to their predrought quantities reduced groundwater withdrawals. The slightly smaller delivery of surface water in 1978 relative to pre-1976 deliveries (Table 1) was caused by abnormal spring and fall rainfall in 1978 that reduced the demand for surface water. In response to decreased groundwater production following the drought the lowest water level measured in 1978 was 14.0 m higher than the lowest water level measured in 1977.

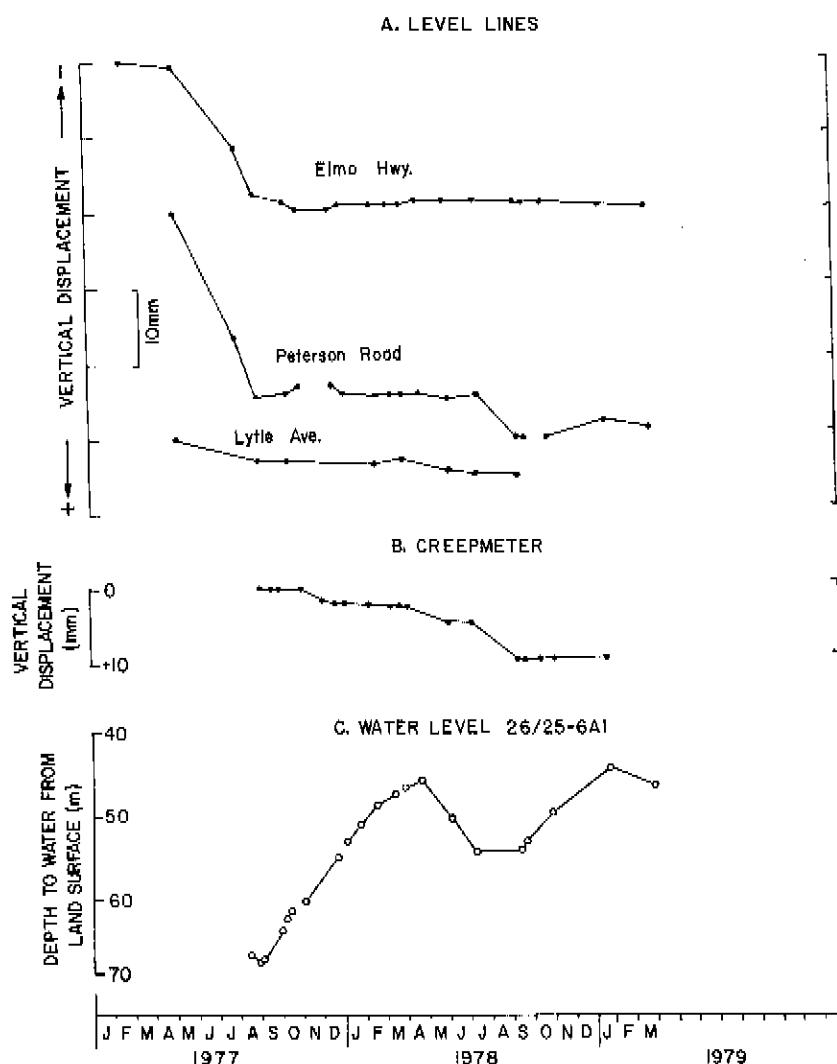
Results from monitoring are summarized in Figures 4a and 4b. Only measurements of differential vertical displacement of the bench marks closest to and on either side of the fault are shown because results from level lines indicated that adjacent

monitoring began in May 1977. During the period from May to September 1977, contemporaneous with the surveys at Elmo Highway, 24.5 mm of fault offset, downthrown to the west, was measured (Figure 4a). From September to November, 1.5 mm of fault offset in an opposite sense to that of the summer may have occurred. The bench marks were subsequently destroyed and were reset in December 1977. No renewed offset was detected until the period from July to September 1978 when 5.5 mm of offset was measured. Taping between the bench mark pair across the fault at Peterson Road, accurate to 1 mm, detected no horizontal movement associated with the faulting in 1978. Measurements 8 days apart in September indicate that fault movement had halted prior to the date of the first measurement in September. Bench marks again were destroyed and were not reset until the end of October. Fault offset at Lytle Avenue from May 1977 to September 1978 was barely detectable. Approximately 3 mm of offset, downthrown to the south, occurred from May to September 1977 (Figure 4a). Results from the creepmeter (Figure 4b), 67 m north of Peterson Road, are in approximate agreement with the results from the monitoring at Peterson Road. The offset of 1.8 mm measured by the creepmeter in November-December

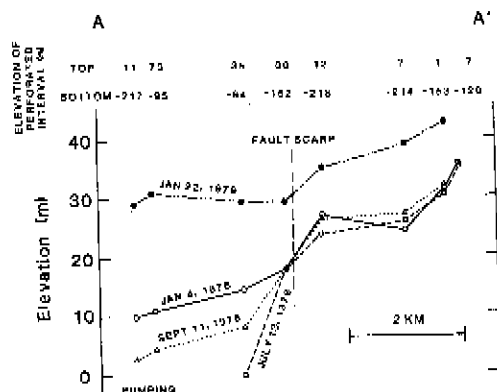
Fig. 5. Profiles of water levels in irrigation wells, January 1978 to January 1979. Elevation (in meters) of top and bottom of reported perforated interval in each well is shown. Top of confined aquifer is approximately at mean sea level. See Figure 2 for location of profiles.

Water levels were measured in 26 accessible wells in January 1978 and 21 wells in July 1978. Less complete surveys were conducted in September 1978 and January 1979. With a few exceptions, when measurements were separated according to the principal aquifer tapped by the well, water levels were consistent for each aquifer. Water levels in wells reported to be perforated in both aquifers, in general, were consistent with water levels in wells reported to be perforated only in the confined aquifer. In January 1978 the difference between water levels in shallow and deep wells, i.e., wells tapping the unconfined and confined aquifers, respectively, was approximately 35 m. The potentiometric surface for the confined aquifer, shown in an east-west profile in Figure 5, sloped in a westerly direction. During the summer of 1978, water levels in

deep wells on the west side of the fault scarp declined approximately 12 m as contrasted with declines of 3 m or less on the eastern side of the fault scarp. This response, in part, was caused by the distribution of pumping during the summer. The area west of Highway 43 (see Figure 2), although under cultivation, received negligible surface water and hence was largely dependent on groundwater. Pumping in 1978 east of Highway 43 in the study area was minor. Despite the large declines measured in the deep wells, water levels in shallow wells changed less than 1 m from January to July.
